HISTORIC STRUCTURES REPORT

BRICK WALKS
HISTORIC STRUCTURES REPORT

WILLIAM HOWARD TAFT
National Historic Site

BY MARK A. CHAVEZ
Regional Historical Architect

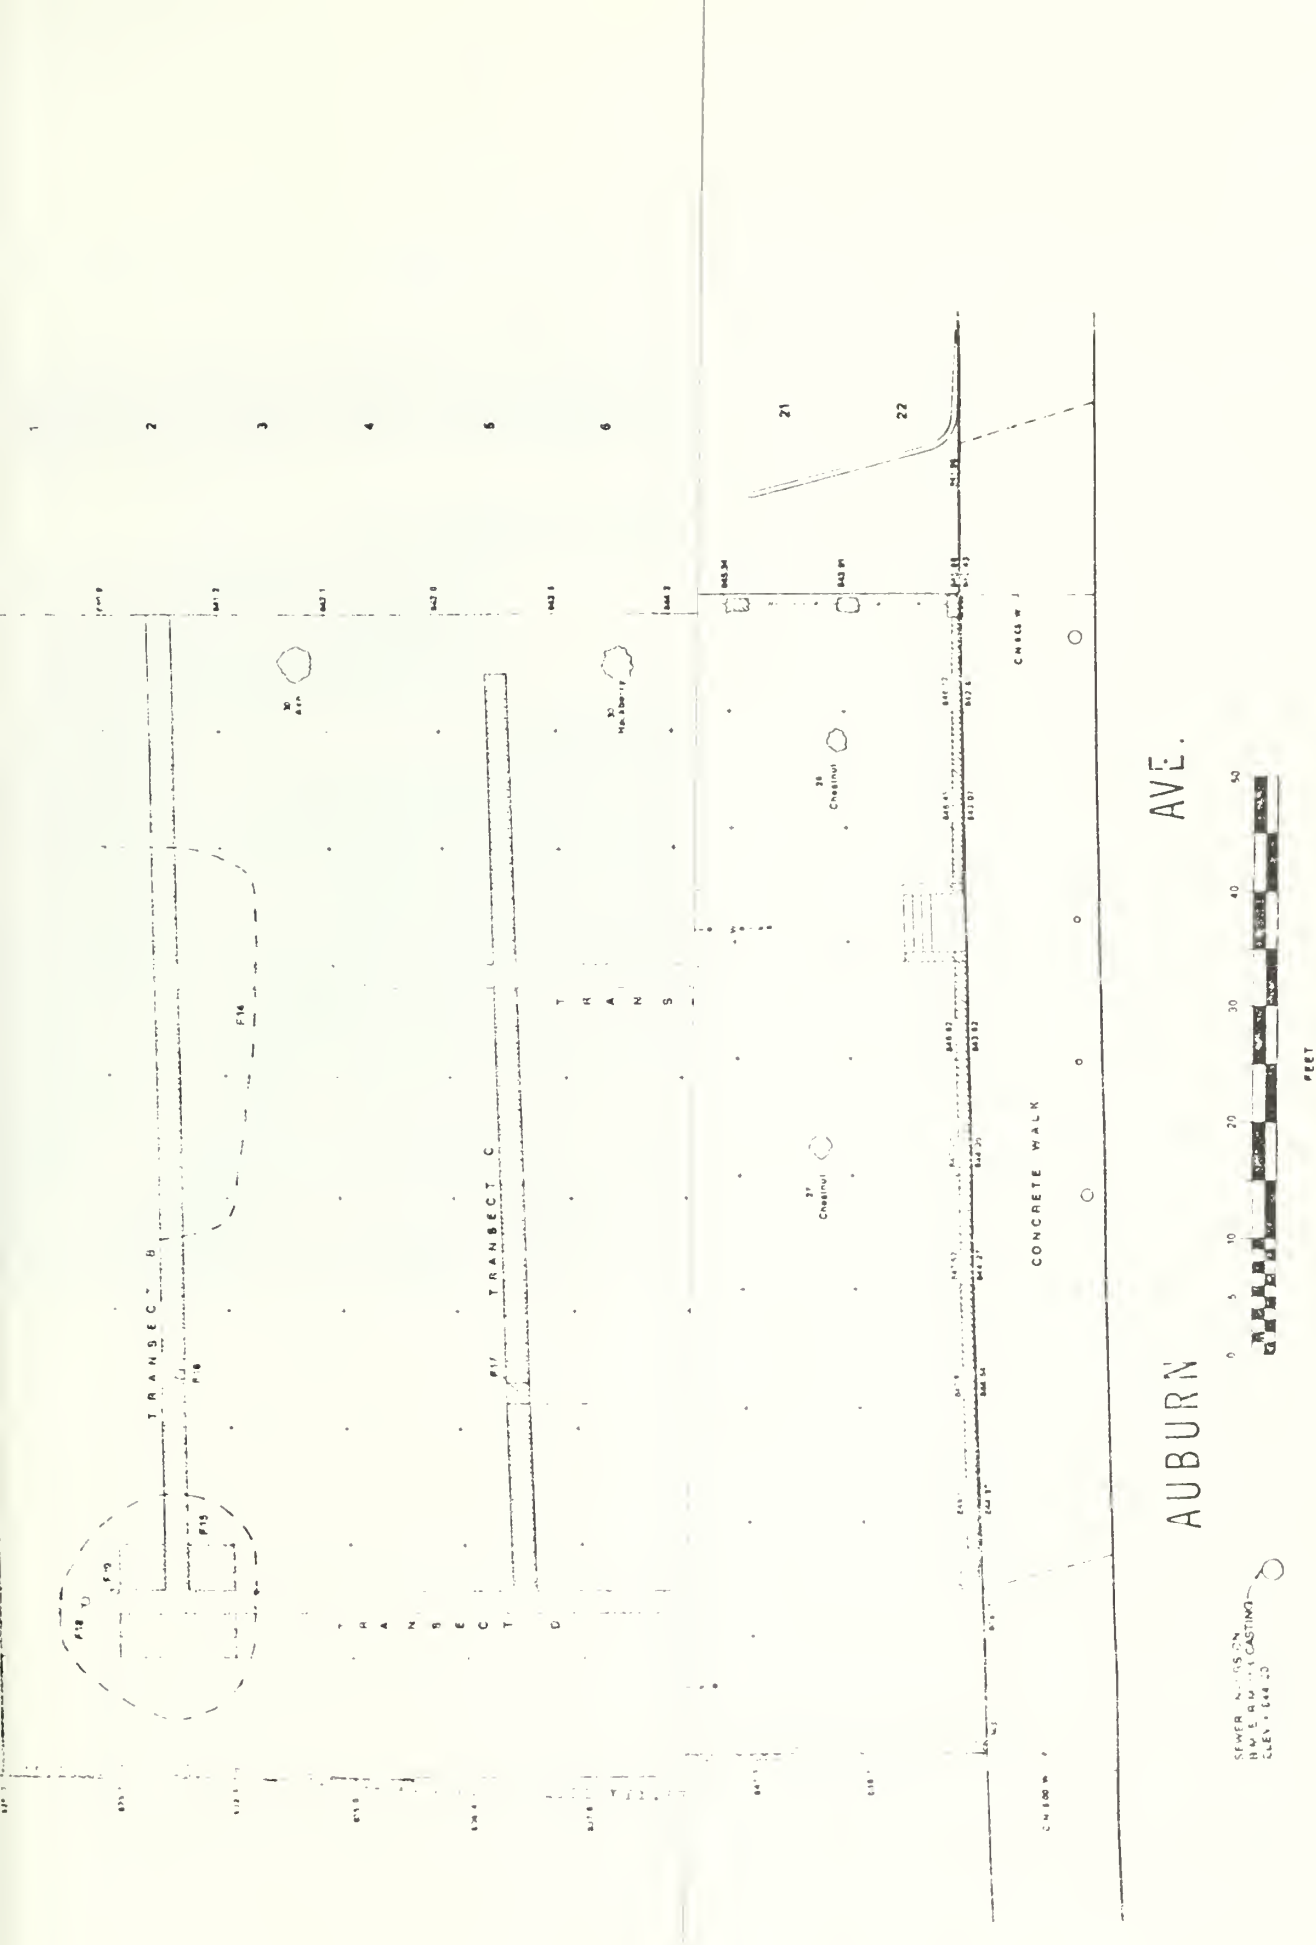
FIGURE 3.10 SITE PLAN OF ARCHEOLOGICAL FEATURES (McCollough 1972)

The truncated remains of herringbone-patterned brick paving (Feature #7) [see Figure 3.10] shown on a ca. 1920 photograph (McCollough 1971: Plate VIII) [see Figure 3.1] were found at the eastern edge of the cement sidewalk (Plates XVII and XVIII) [see Figures 3.12 and 3.13, respectively], incorporated in the base of the Level II humus and resting directly on the surface of

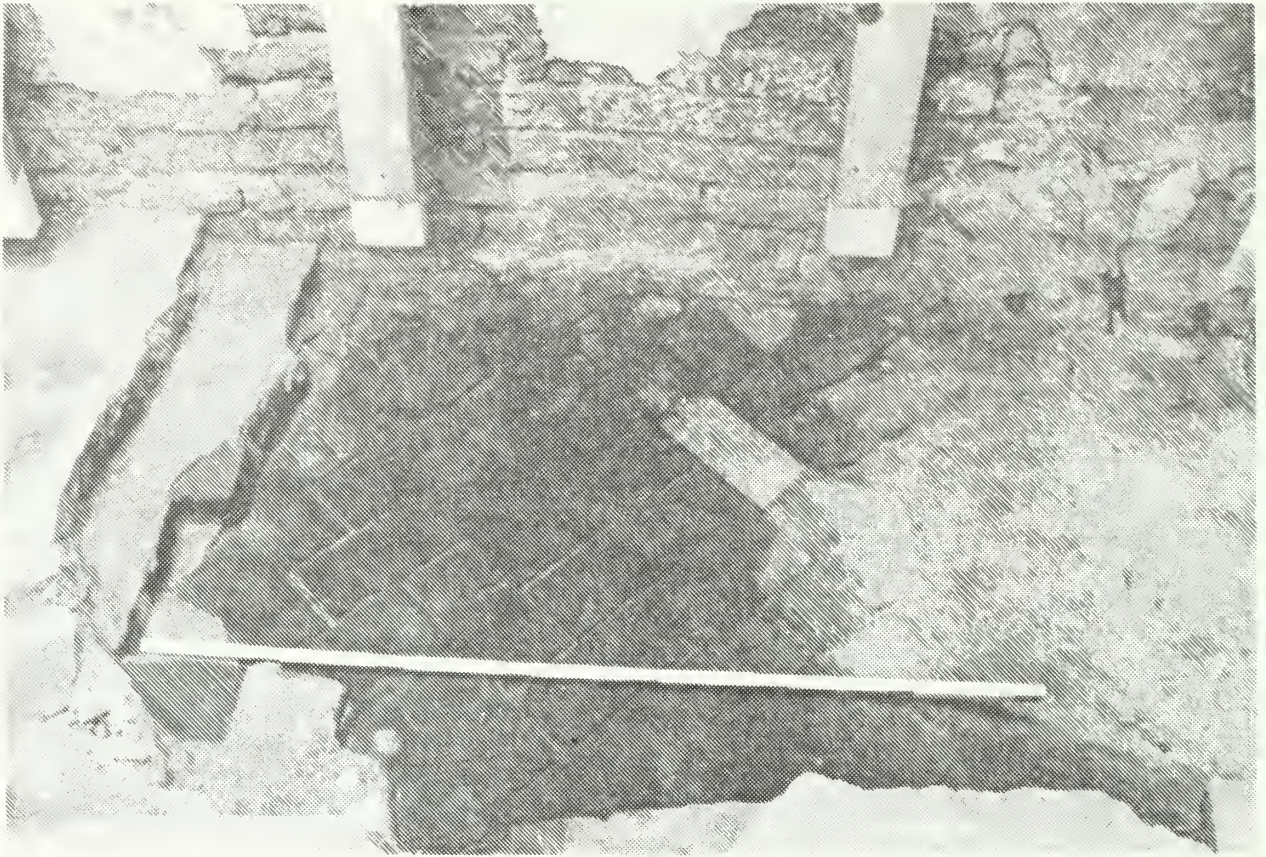
FIGURE 3.22

Concrete walks in this area, when removed, revealed a layer of vitreous brick pavers beneath. Under these pavers was a layer of paving similar to what is seen in this photograph. The brick type matches Perry's analysis of historic paving, as does the method of construction (dry-laid in sand) and the pattern (diagonal herringbone).

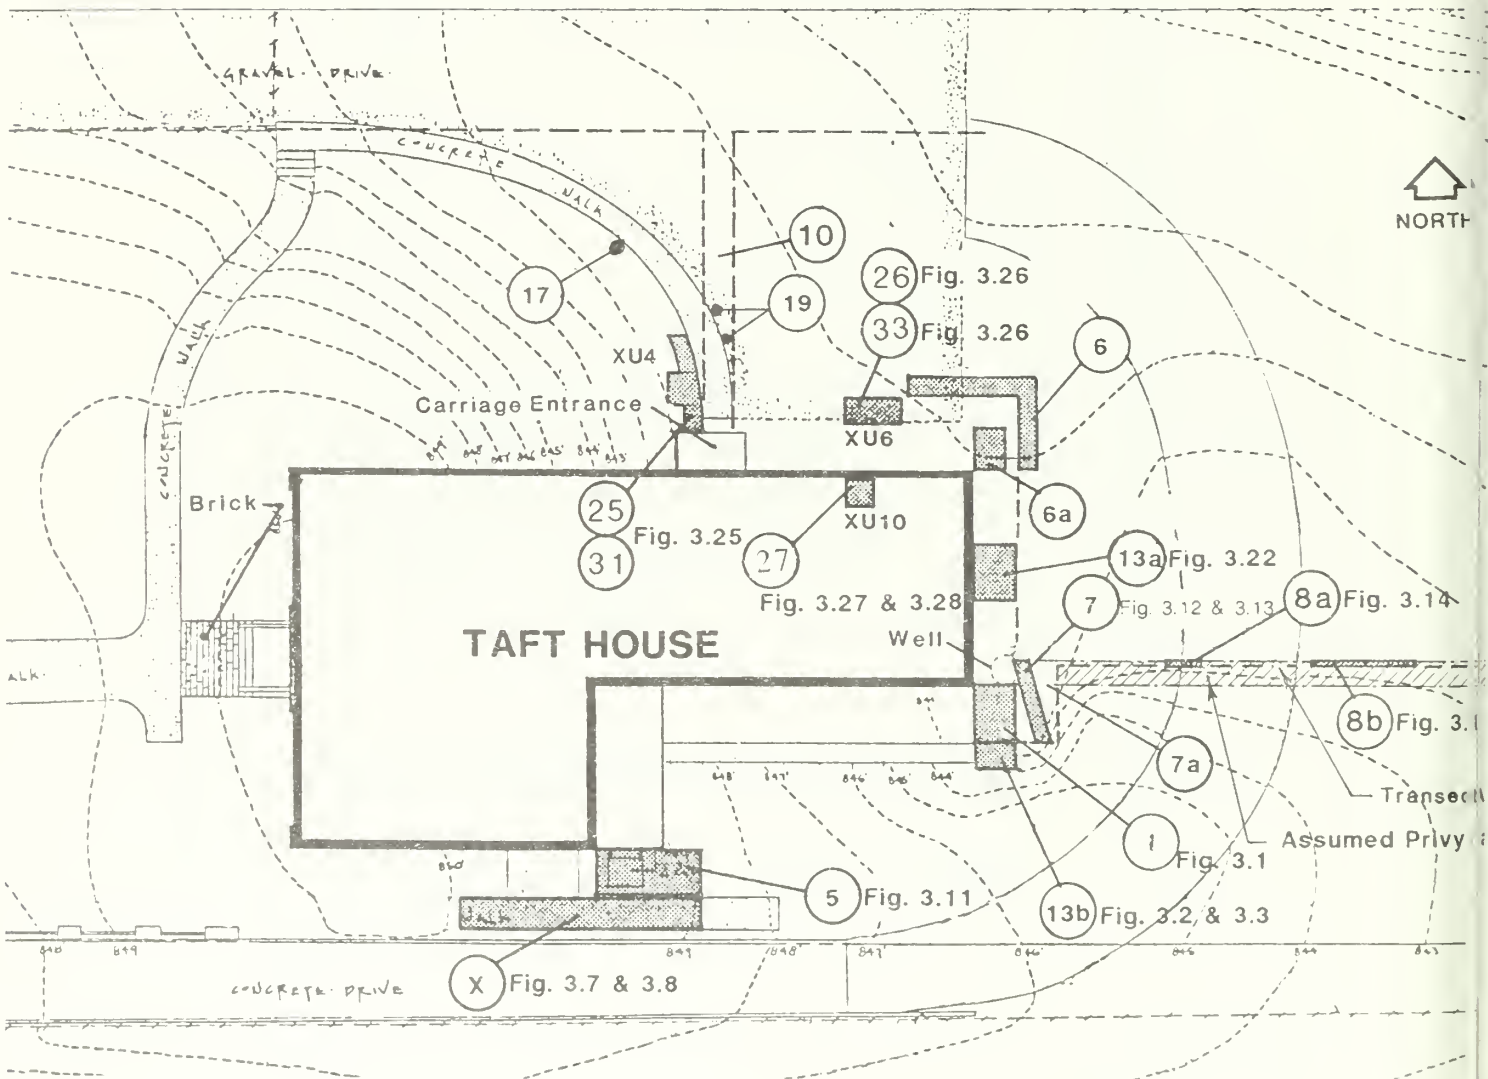
FIGURE 5.2

26 and 33. Perry's investigations of XU 6 revealed two layers of brick paving under the concrete sidewalk: first a non-historic layer of the McManigal variety, and beneath that, historic paving.

27. Historic paving was discovered in the basement by Perry. It was assumed that this paving belonged to the "back piazza."

For the purposes of this report, Walks 2, 3, 6, and 7 will be reconstructed based on conclusive historical and archeological research. The privy walk (number 1) has also been supported, but regrading of the existing site will have to be accomplished prior to its reconstruction. Walks 4 and 5 will remain as concrete sidewalks until further archeology can be performed in these areas. Walk 8 will not be reconstructed at this time.

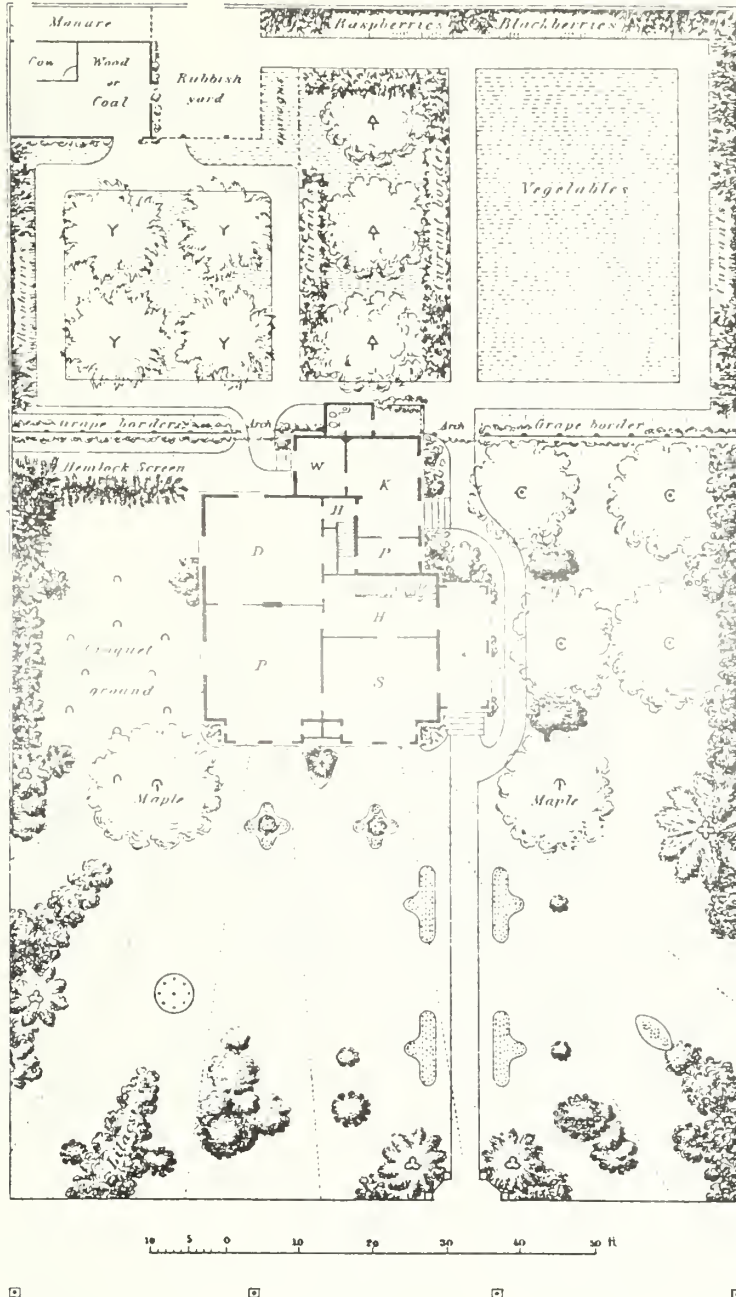
FIGURE 5.3

Walk number 5 (north front walk, from steps near carriage drive to west entrance): There is no evidence, archeological or historical, to support the existence of this walk. As stated earlier, such a walk would have certainly made sense historically. Figures 5.3-5.7 (from Frank J. Scott's 1870 edition of Suburban Home Grounds) show typical layouts for residential properties in the mid- to late-1800s. Perry's discovery of the McManigal brick would support this contention, as would the following, from Superintendent Steve Kesselman's memorandum dated May 26, 1987:

This figure and the succeeding four figures indicate possible arrangements of walks around homes of the nineteenth century. Note the walk which leads from the main entrance around to the kitchen in each case, possibly supporting a similar case for the Taft home. (Unsupported historically or archeologically).
